ANNUAL REPORT FOR 2010

Stella Bridge Mitigation Site
Onslow County
TIP No. B-2938

Prepared By:
Natural Environment Unit & Roadside Environmental Unit
North Carolina Department of Transportation
December 2010

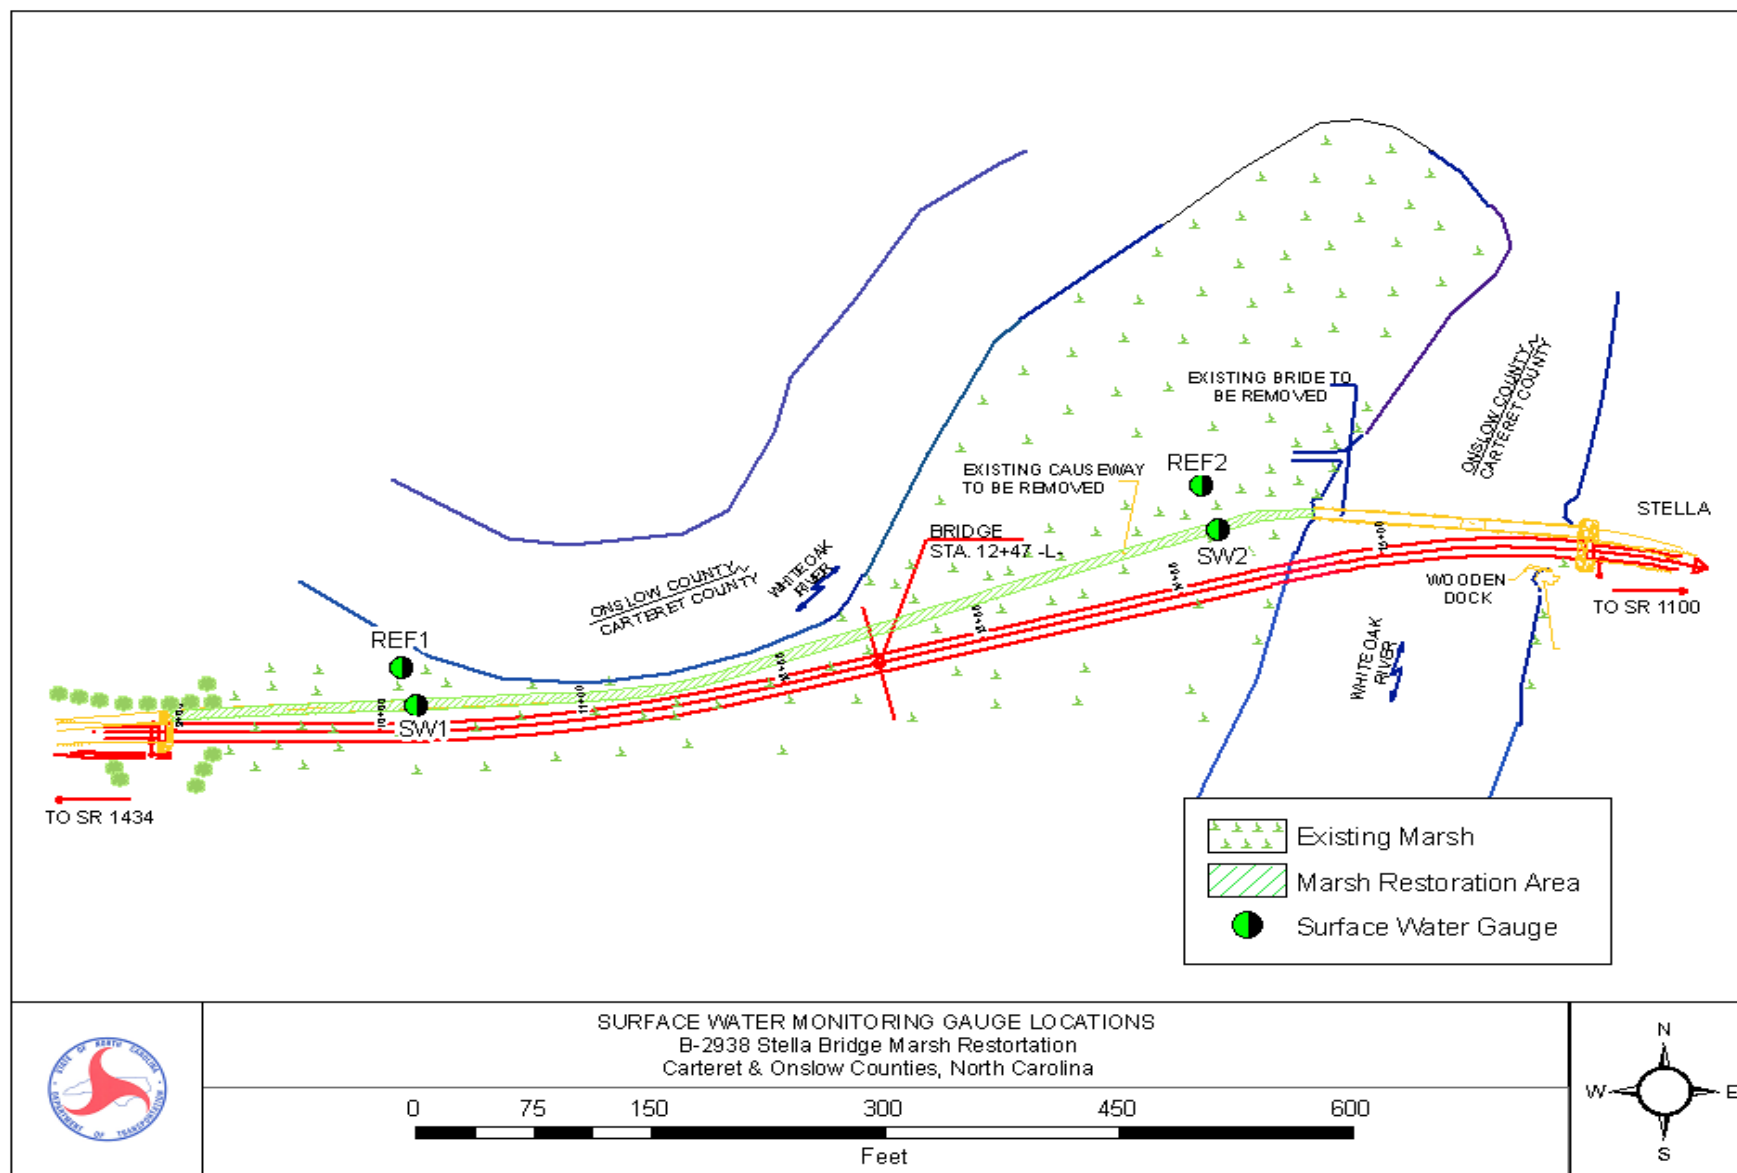
Figure 2. Monitoring Gauge Location Map

In March 2006, four surface water gauges were installed to monitor hydrology on the site. Two of the surface gauges were positioned in the restoration portion of the mitigation site. Two surface gauges were installed as reference gauges within the adjacent preservation area.

Hydrologic monitoring occurs throughout the growing season in the restoration area by using surface water gauges. Two surface water gauges were placed in the restored Brackish Marsh area. Two surface water gauges were placed in the reference Brackish Marsh area located within the project area. Hydrologic success criteria was based on the establishment of hydrologic conditions comparable in hydrologic frequency and duration to those of the existing reference wetlands. The surface water gauges record surface water levels every three hours. Monitoring data for 2010 represents the fifth year of hydrologic monitoring for the site.

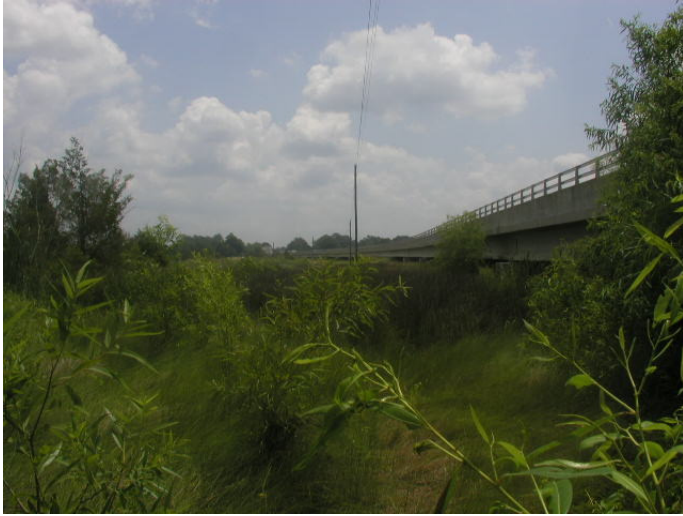
Photo 1

The site was planted in May 2006. Planted vegetation is surviving and spreading throughout the site. Frequency and coverage are on track for year five.
